## Fire Investigation Report

Combustion Explosion  
60 Grosvenor Street  
Buffalo, New York  
December 27, 1983  
7 Fatalities

Richard L. Best  
Senior Fire Analysis Specialist  
National Fire Protection Association

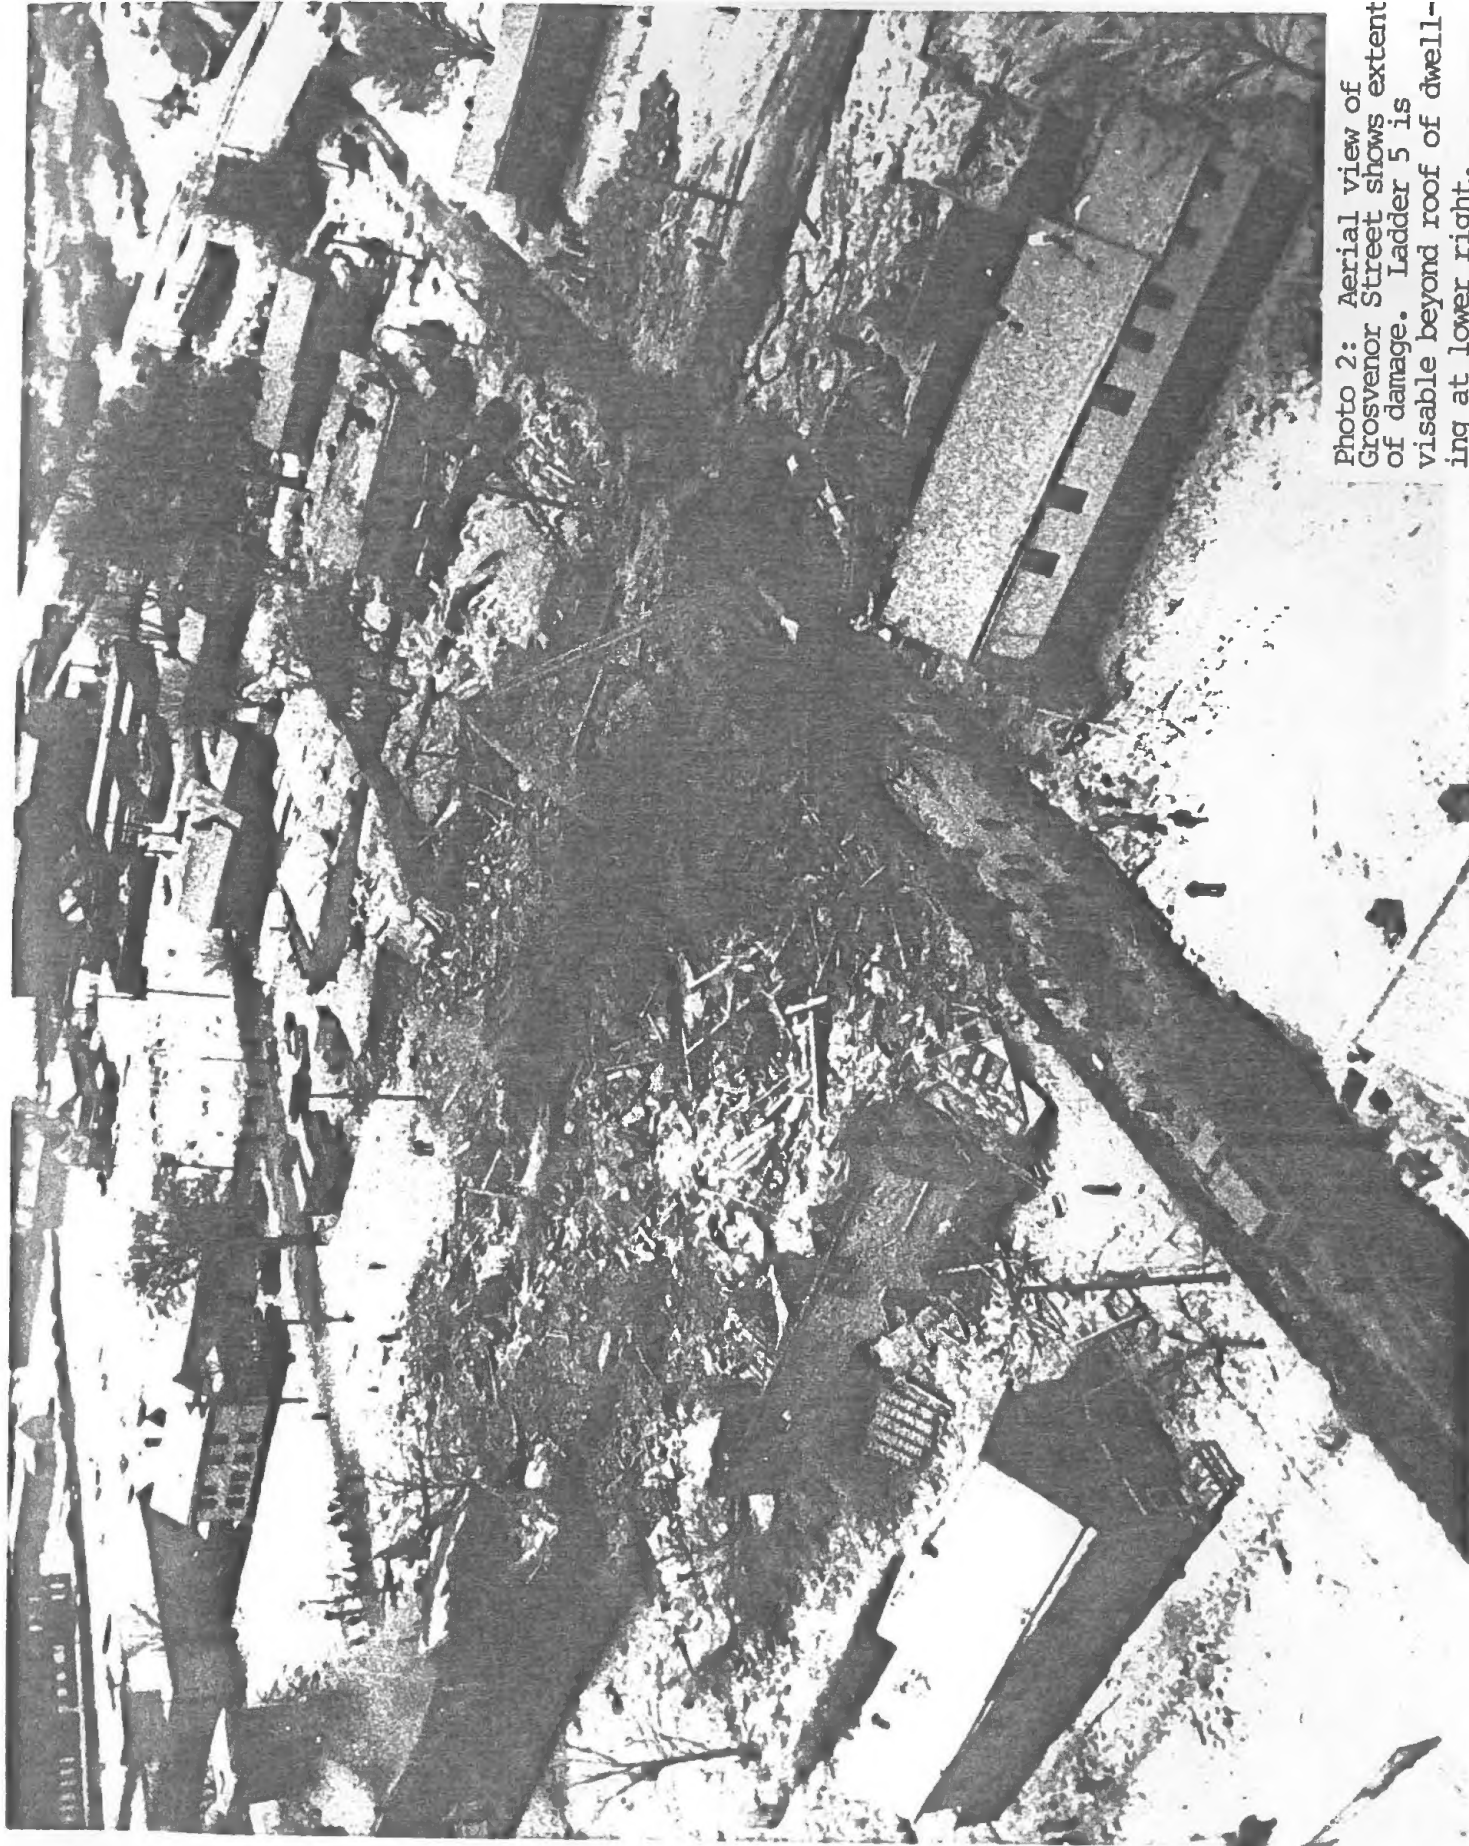
Photo 2: Aerial view of Grosvenor Street shows extent of damage. Ladder 5 is visible beyond roof of dwelling at lower right.

Damage resulting from the combustion explosion was severe in a 200 to 300 yard radius of the Grosvenor Street plant. Additional damage, mostly broken glass, extended hundreds of yards beyond the severe explosion damage and fire damage areas. A commercial building across Grosvenor Street was destroyed as was a church north of the explosion site. Most other buildings damaged in the incident were wood frame dwellings on all sides of the Grosvenor location. Fourteen buildings were totally destroyed and 84 buildings received damages ranging from minor to severe. The preliminary estimate of damage is \$10 - \$20 million.

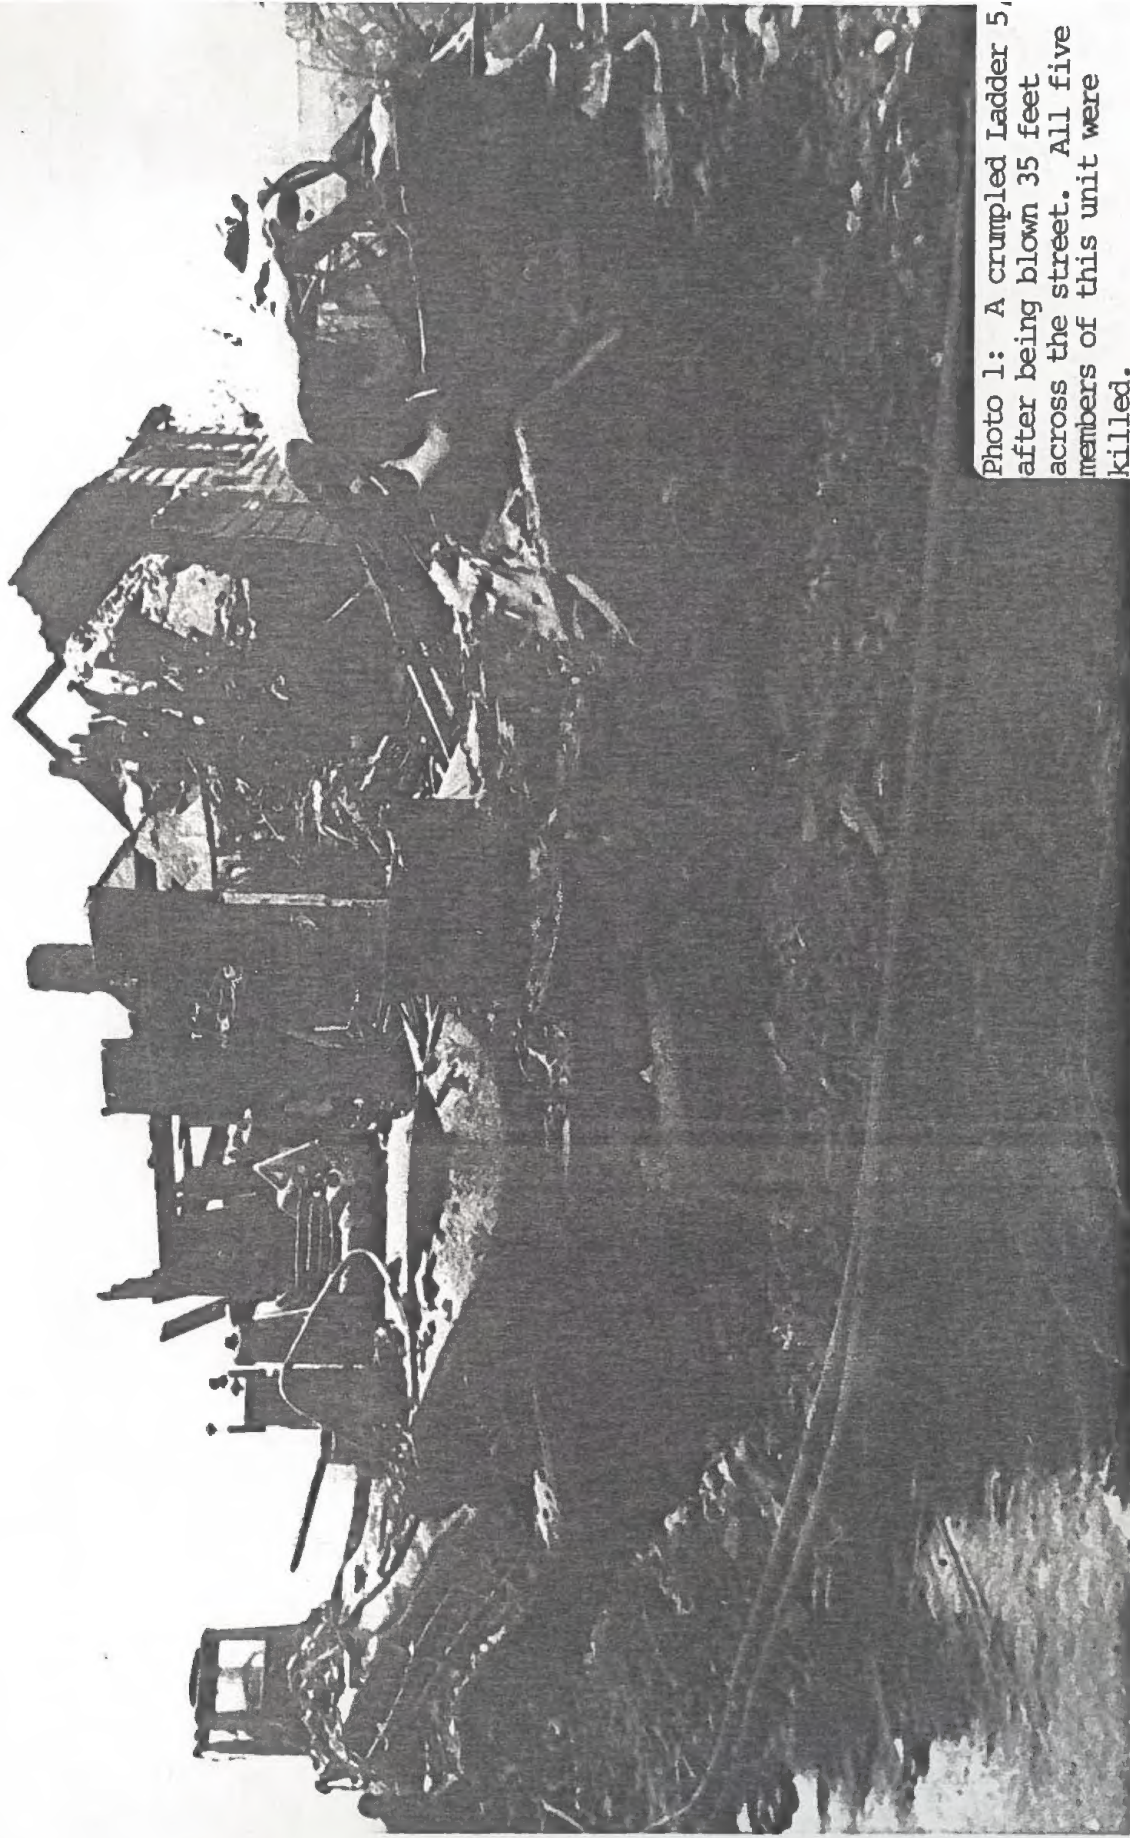
Photo 1: A crumpled Ladder 5, after being blown 35 feet across the street. All five members of this unit were killed.

The Buffalo Fire Department received the alarm at 8:23 p.m. The report to the Fire Department was that a "500 gallon tank bursted (sic)" in the building. Three engine and two ladder companies responded along with a heavy duty rescue and Battalion Chief Harvey Supple. Ladder truck 5 had arrived in front of the building on North Division Avenue, Engines 1 and 32 were parked on North Division and Grosvenor and Battalion Chief Supple was parked at the intersection when the explosion occurred. Reportedly the crews had just arrived on the scene and Battalion Chief Supple was just beginning to get information on the situation when a violent combustion explosion disintegrated the Grosvenor building. The force of the explosion threw the ladder truck across the street, moved both engines, and caused severe blast and missile damage to buildings in the immediate vicinity of the plant.
